Precision 20/20
Full Reserve Study
for
Lake McQueeney Las Brisas
Homeowners Association
Seguin, Texas
May 11, 2010

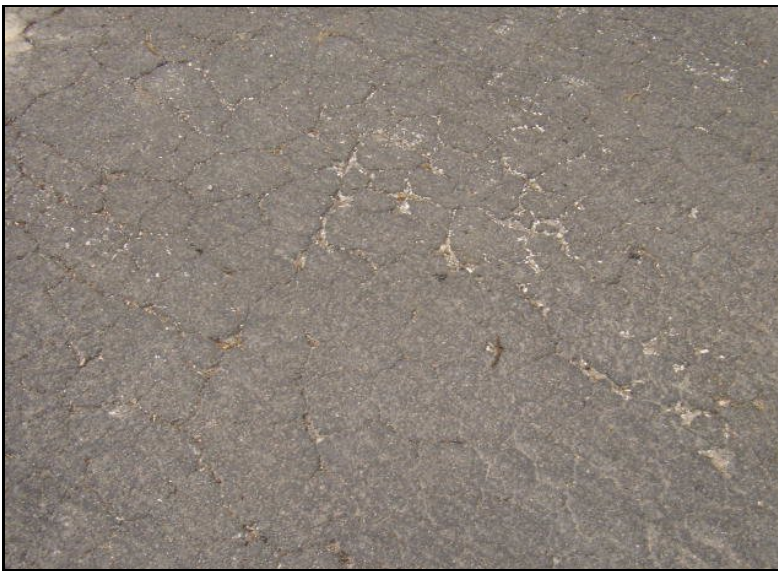
Asphalt pavement

Note: Alligator cracks

Las Brisas should repair any isolated areas of deteriorated pavement prior to the Flexseal™ applications. Proposals for Flexseal™ applications should include both crack repair and area patching. These activities reduce water infiltration and the effects of inclement weather. The contractor should only apply Flexseal™ applications after remedial crack and surface repairs are completed. Our future estimates of cost include an allowance for both crack repair and area patching.

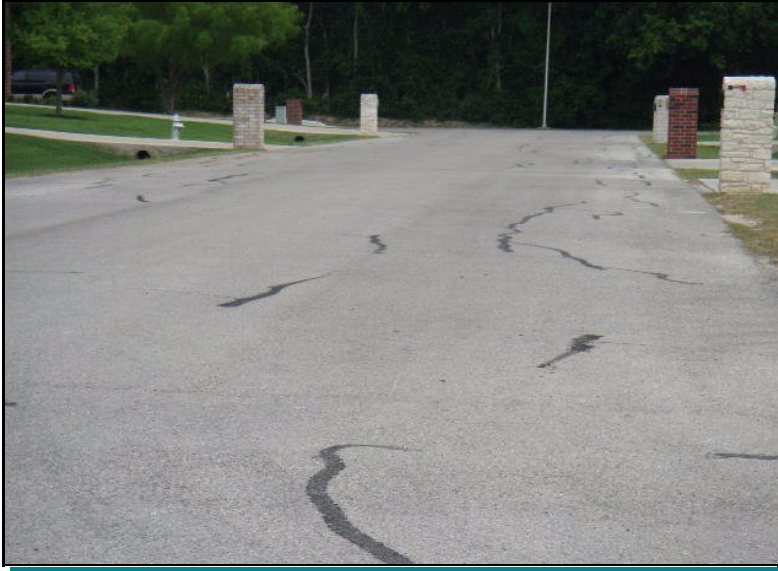
Asphalt pavement

Note: Crack repair

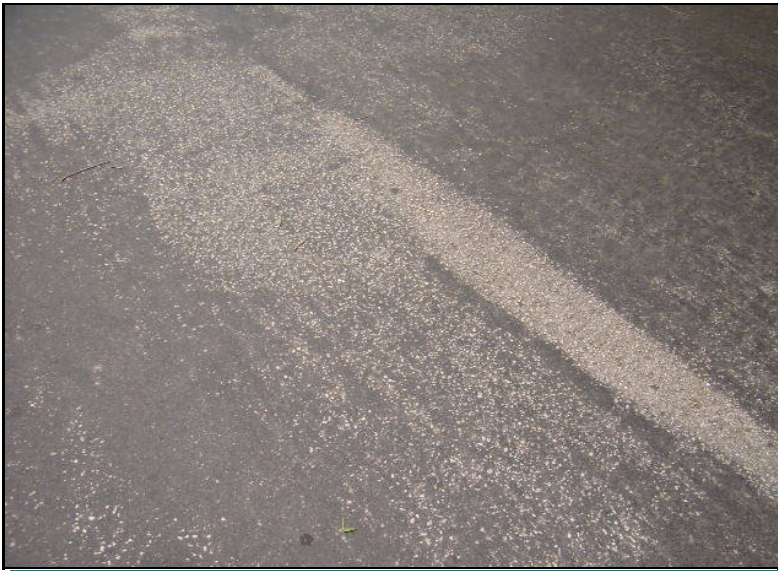
Asphalt pavement

Note: Seal coat deterioration

We recommend that Las Brisas plan the next phased application of Flexseal™ beginning by 2014 and concluding by 2019. Subsequent phased applications are likely every ten years

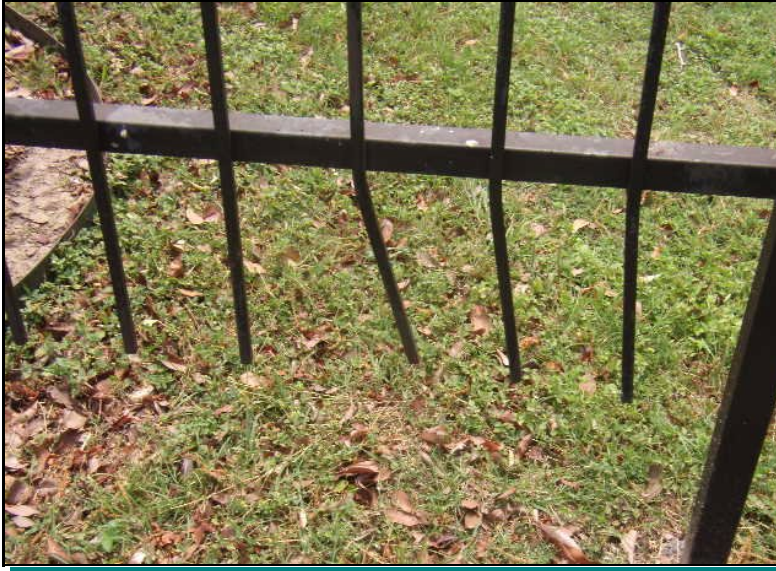
Fences, Metal - Approximately 365 linear feet of metal fences line the entrance of the property. The fences are in good *overall* condition at an age of 23 years. We note isolated areas of damage and rust. Page 4 of **Exhibit A Photographs** depicts these conditions. Fences of this type have a long useful life but are not maintenance free. Periodic maintenance should include periodic applications of protective paint finish to the metal surfaces and partial replacement of deteriorated sections as needed. Metal components at grade and key structural connections are especially prone to failure if not thoroughly maintained. Secure and rust free fasteners and connections will prevent premature deterioration. The protective finishes are in fair overall condition. The Association should also apply periodic paint applications as normal maintenance funded through the operating budget. We anticipate replacement of the fences by 2022 and depict this information on Line Item 4.245 of **Exhibit B Reserve Expenditures**.

Metal fence

Note: Damage

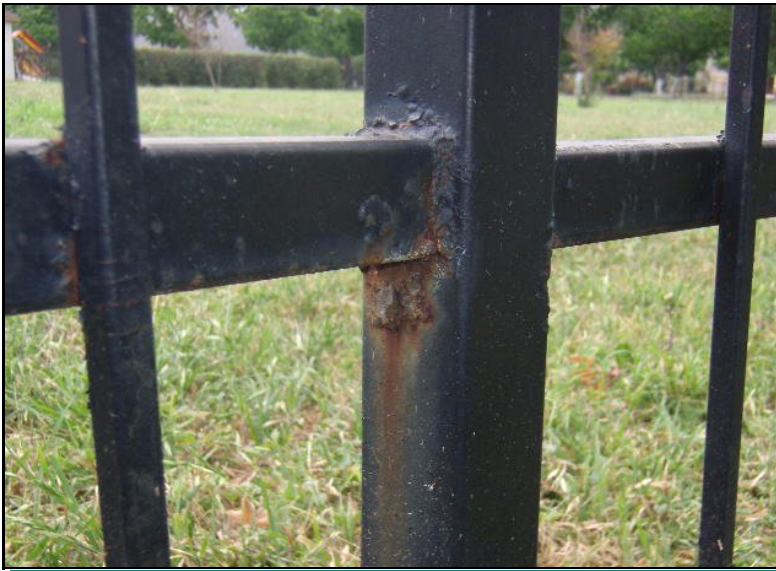
Metal fence

Note: Rust

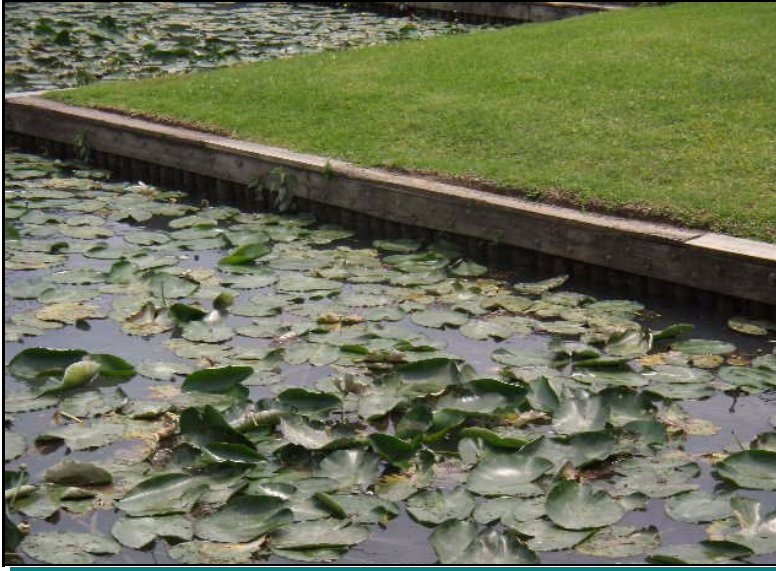
Lake, Bulkhead - Las Brisas maintains approximately 2,700 linear feet of bulkhead which comprises both wood and vinyl composite sections. The bulkhead is in good to poor condition at ages of up to 23 years. The Association is currently in the process of replacing the wood bulkhead with a vinyl composite bulkhead. The Association has spent \$125,310 since beginning the partial replacements in 2006. We anticipate a useful life of 25 to 30 years for the vinyl composite bulkhead. We recommend the Association budget for replacement of the remaining approximately 1,890 linear feet beginning in 2011 and concluding by 2017. A subsequent phased replacement is likely beginning by 2033. We depict this information on Line Item 4.703 of **Exhibit B Reserve Expenditures**.

Wood bulkhead

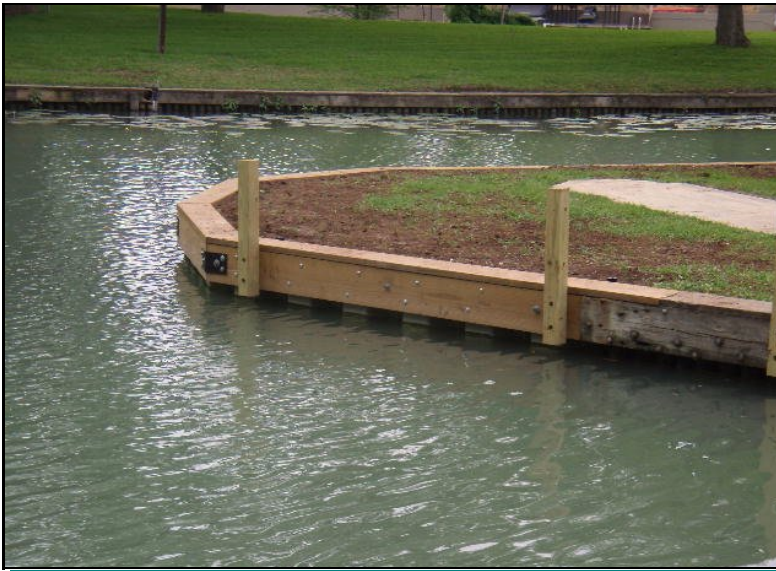
Vinyl bulkhead

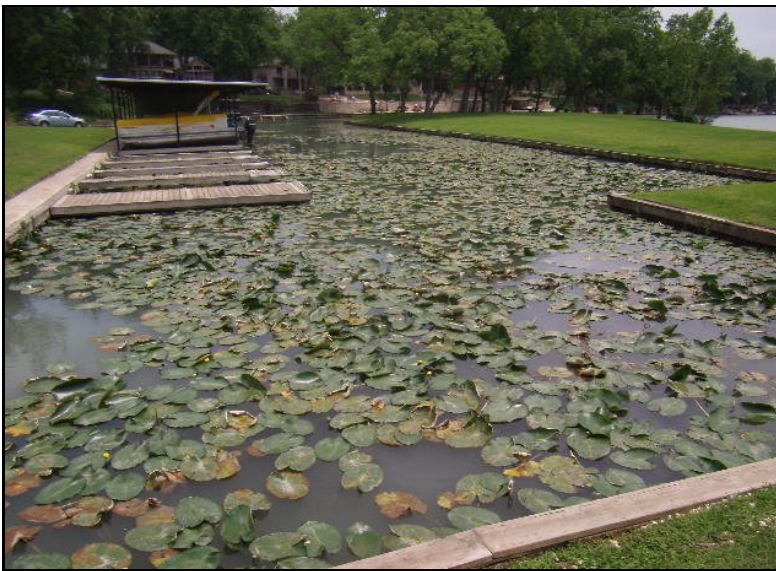
The Association maintains approximately 4,700 square yards of water surface area. Based on the visual condition of the lake and reported issues with boats not being able to pass through the marina without incident, we recommend the Association anticipate the need to dredge the marina portion of the lake. However, the actual volume of material to dredge may vary dependent upon an invasive analysis at the time of dredging. We conservatively recommend that the Association defer this variable but probable activity until 2015, due to

Lake overview within Marina

Note: Lily pads

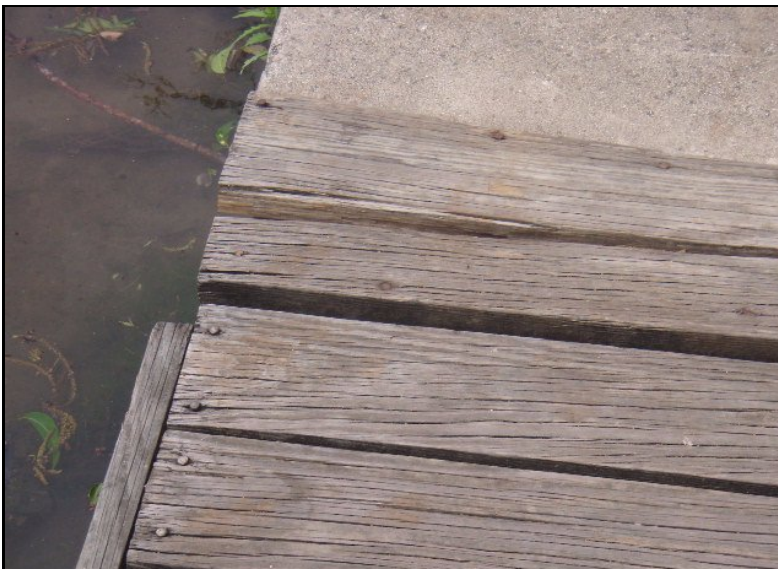
Boat Slips, Wood - Approximately 1,400 square feet comprise the boat slips at the marina. The boat slips are in poor condition at an age of 11 years. We note areas of warped and split sections of boards. Page 7 of **Exhibit A Photographs** depicts their conditions. The boat slips have a useful life of 10- to 15-years. We recommend the Association budget for their replacement in 2011 and every 12 years thereafter. We depict this information on Line Item 7.381 of **Exhibit B Reserve Expenditures**. Our estimate of cost includes an allowance for replacement of up to twenty-five percent (25%) of the wood piles.

Wood boat slip

Note: Board warp and split

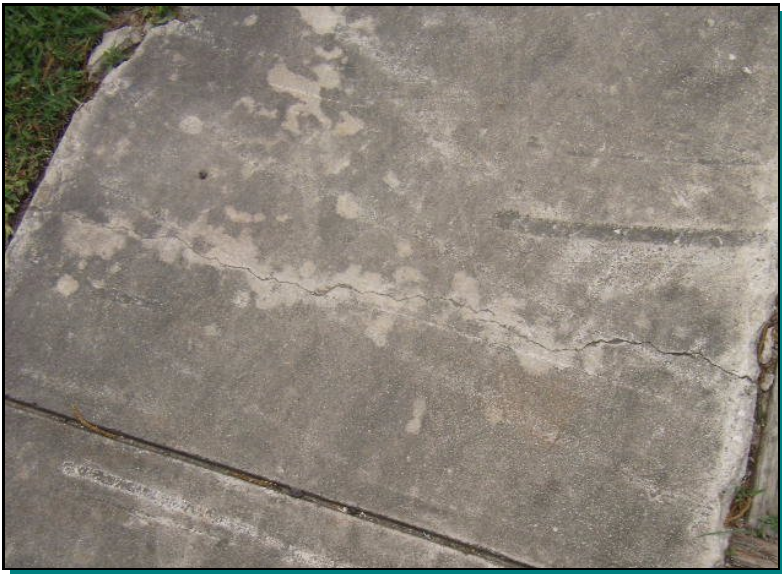
Concrete Sidewalks - Concrete sidewalks comprise approximately 1,550 square feet at the marina. The sidewalks are in fair overall condition.

Concrete sidewalk

Note: Crack

The Association should coordinate the concrete flatwork partial replacements, this will permit the use of a single contractor and likely achieve the most economical unit price for the work. We estimate that up to 1,050 square feet of the concrete flatwork, or fifty percent (50.4%) of the total, will require replacement during the next 30 years. We recommend the Association budget for replacement of 350 square feet of concrete flatwork every ten years beginning in 2011. The times and costs of these replacements may vary. However, the estimated expenditures detailed on Line Item 7.392 **Exhibit B Reserve Expenditures** are sufficient to budget appropriate reserves. We also recommend an annual inspection of the sidewalks to identify potential trip hazards. We suggest that the Association grind down or mark these hazards with orange safety paint prior to replacement and fund this ongoing activity through the operating budget.

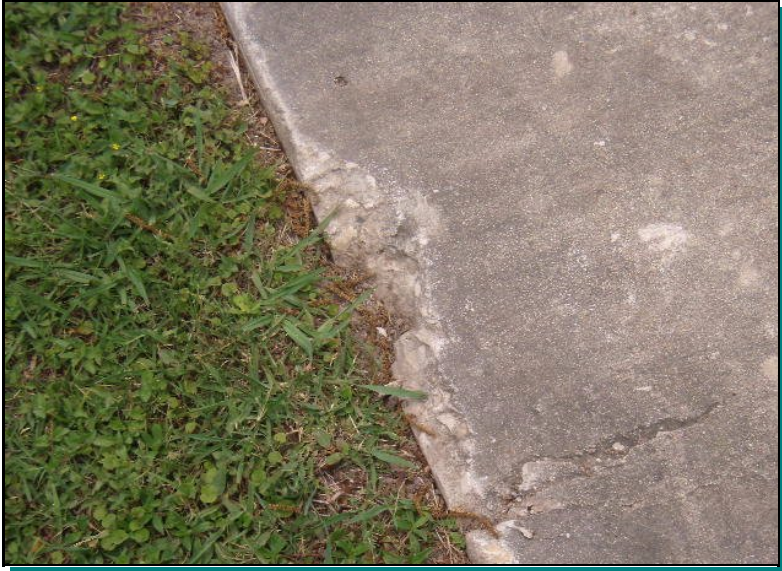
Concrete sidewalk

Note: Spall
